Date February 25, 2016
Contact person
Extension number +31 70 333 7000
Your reference 4.02-3
Our reference OvV-16500274
Project MH17

Subject Assessment of the information provided in your letter of January 14, 2016

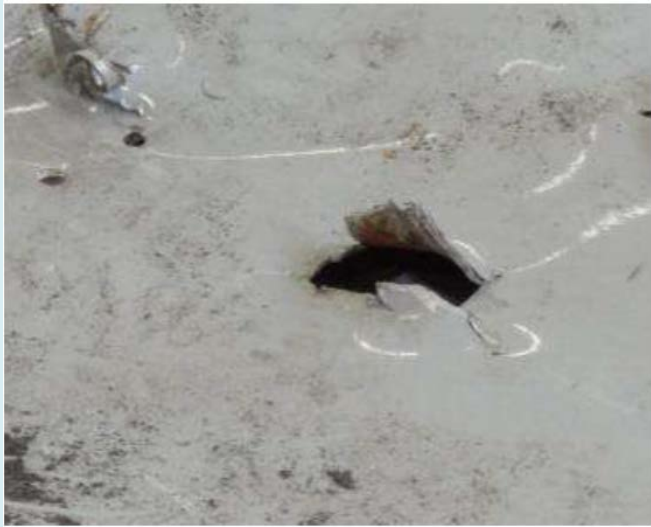
Russian Federation argumentation	Dutch Safety Board assessment
	<p><i>The fact that hundreds of fragments were found in the bodies of the three crew members in the cockpit illustrated that the path of the fragments was affected.</i></p> <p>3. For the arguments regarding the presence of penetration holes in the right side of the cockpit reference is made to section 2.4, page 13 of the NLR report (Appendix X of the MH17 Crash report): <i>Exit damage is observed on the wreckage of the lower right-hand side of the cockpit (Figure 10). This is an indication of a direction of impact from the upper left-hand side of the cockpit towards the lower right-hand side of the cockpit.</i></p>

<p><i>Figure 10: Exit damage on lower right-hand side of the cockpit</i></p> <p>The Dutch Safety Board concludes that on the basis of the arguments put forward, there is no new and significant evidence.</p>
<p><i>“The new important fact is that the appearance of the Section 3 encasing fragment found at the crash site does not match the appearance of fragments of the same encasing normally resulting from the detonation of a 9M38-series (9M38M1) missile.”</i></p>	<p>For the response to the Russian Federation's argument regarding the so-called 'Section 3 encasing fragment' reference is made to the text in paragraph 2.12.2.8 of the MH17 Crash report:</p> <p>Ref.: MH17 Crash, paragraph 2.12.2.8, pages 82-83: <i>(...) In order to not risk impeding the criminal investigation, the Dutch Safety Board has decided not to publish images of all of the recovered fragments that were presented to the Annex 13 partners during the progress meeting in August 2015. Images of three of the parts are shown in Figure 36.</i></p> <p><i>The shape and form of the parts recovered is consistent with a 9M38-series surface-to-air missile. Images of three of the recovered parts are shown in Figure 36 together with an indication of origin on a 9M38 series surface-to-air missile; namely an engine nozzle (1), part of one of the four stabilizer fins (2) and a data cable (3).</i></p> <p>The text in the report makes it clear that the Dutch Safety Board makes no pronouncements as to whether the 'Section 3 encasing fragment' comes from the surface-to-air missile that downed the aeroplane. That is part of the criminal investigation.</p>

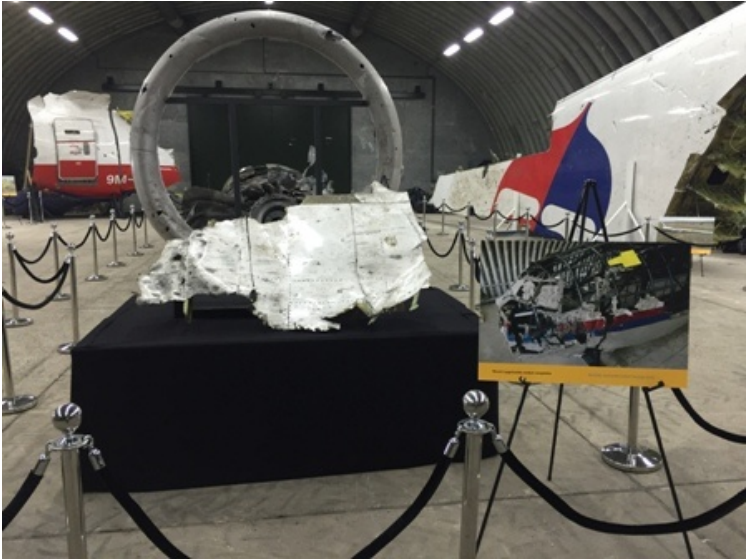
Russian Federation argumentation	Dutch Safety Board assessment
<p>2. the missile warhead detonation area;</p> <p>3. discrepancies in static and dynamic warhead simulations.</p>	<p>Furthermore, for the response to the first argument of the Russian Federation, reference is made to the text in Appendix V of the MH17 Crash report in response to the Russian Federation's comments on paragraphs 2.19.4, 3.7.1 and 3.7.2 of the draft Final Report:</p> <p>Ref.: MH17 Crash, Appendix V, Consultation Part A: Causes of the crash, page 6/21 and 11/21: <i>(...) it is a well known fact in the study of terminal ballistics of fragments that a fragment hitting a plate at an oblique angel (not perpendicular to the plate) changes its direction of travel after penetration. The initial angle is typically reduced after penetration. This change in angle is dependent on several factors and can be as small as several degrees or as large as the original oblique angel. As a result, it is usually not possible to obtain accurate data on the direction of travel of fragments outside the structure by studying parts inside the structure.</i></p> <p>With regard to the three pieces of wreckage provided by Channel RT (see photo below):</p> <p>These pieces of wreckage came from the upper left side of the cockpit. Two of these pieces were received in Ukraine on 30 September 2015 and the last piece was received on 3 October 2015. On 8 October these three pieces arrived at Gilze-Rijen Air Base. The Dutch Safety Board has assessed these pieces in the same manner as all the other pieces of wreckage.</p> <p>The damage and damage pattern of these three pieces matched the damage and damage pattern of the pieces of wreckage already recovered.</p>

<p><i>Figure: The three pieces of wreckage provided by Channel RT, as presented (in reconstructed form) on 13 October 2015 (Source: Dutch Safety Board)</i></p> <p>2. For the response to the second argument of the Russian Federation regarding in this matter, reference is made to Appendix L of MH17 About the investigation report:</p>

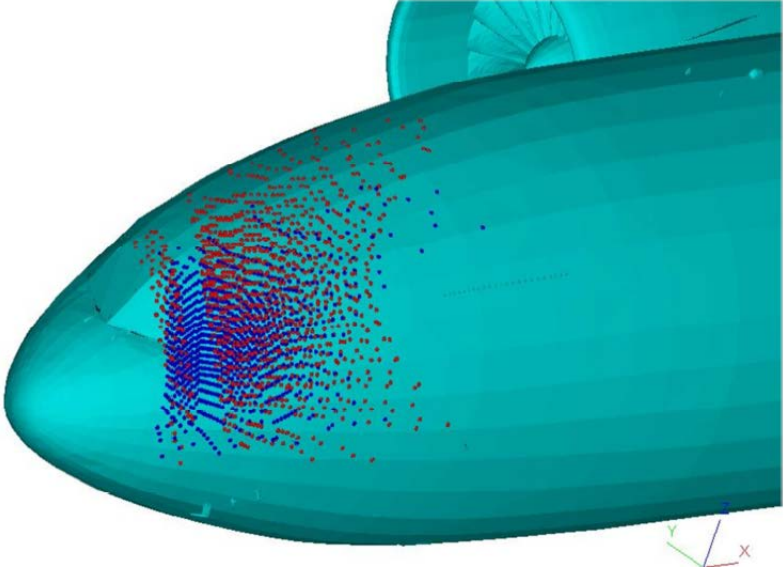
Russian Federation argumentation	Dutch Safety Board assessment
	<p>In section 5.4, pp. 22/25 - 23/25 of the TNO report (Appendix Y of the MH17 Crash report) it says:</p> <p><i>During the Investigation the possibility of a lighter warhead (lighter than 70 kg) was discussed. The hypothesis is that a match with the observed damage is found when a lighter warhead would detonate closer to the airplane. In consultation with the DSB a simulation was set-up whereby a 40 kg warhead detonates within 1.5 m from the airplane.</i></p> <p><i>Detailed results are included in Appendix B. Three different 40 kg warhead designs (A, B, and C) with two possible terminal velocities each (500 m/s and 800 m/s) have been considered. The main difference between the designs is the range of possible fragment ejection angles (design C has the largest range). A partial match is found with design C, which moves at 500 m/s. The other designs do not match because of non-compliance with the set conditions (see Section 5.2). Figure 5.8 illustrates the differences between the best fitting 70 kg and best fitting 40 kg warhead. The 70 kg match is better.</i></p>

<p><i>Figure 5.8: Red: fragment impacts for "best match" warhead design II (70 kg 9N314M). Blue: fragment impacts for "best match" warhead design C (hypothetical 40 kg). Design C results in a less fitting match.</i></p> <p><i>Design C is extreme, in the sense that the angular range of the fragment ejection is made as large as physically possible. Only with an extreme angular range it proves possible to remotely approximate the observed damage pattern.</i></p> <p><i>The damage pattern of a lighter warhead closer to the airplane does not resemble the damage pattern of a heavier warhead further away from the airplane. Therefore, TNO judges the hypothesis that a lighter warhead can cause the observed damage as being improbable.</i></p>
